Davidson County Tornado

...2 TORNADO TOUCHDOWNS CONFIRMED NEAR IN DAVIDSON COUNTY NORTH CAROLINA...

Location...Linwood in Davidson county North Carolina

Date...03/28/2010

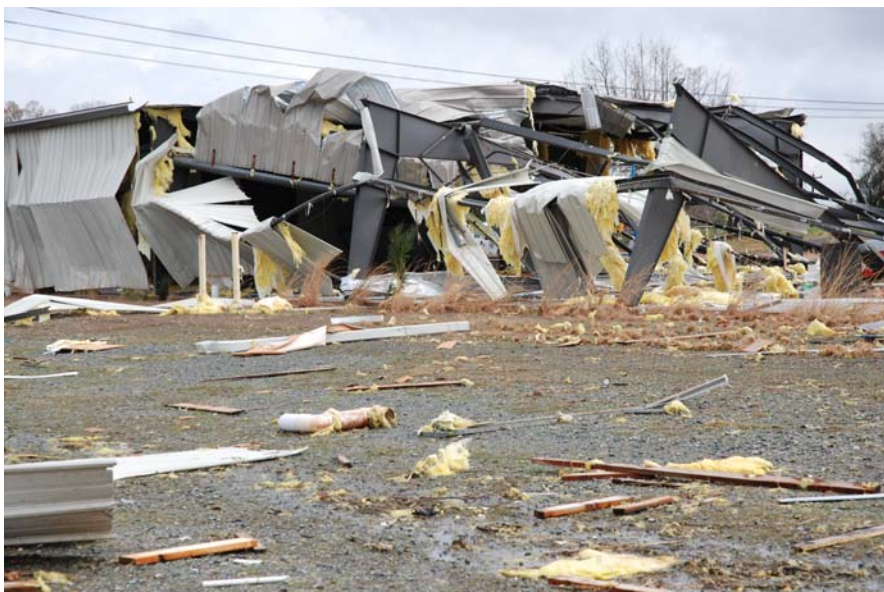
LINWOOD TORNADO - U.S. FLEA MARKET BUILDING

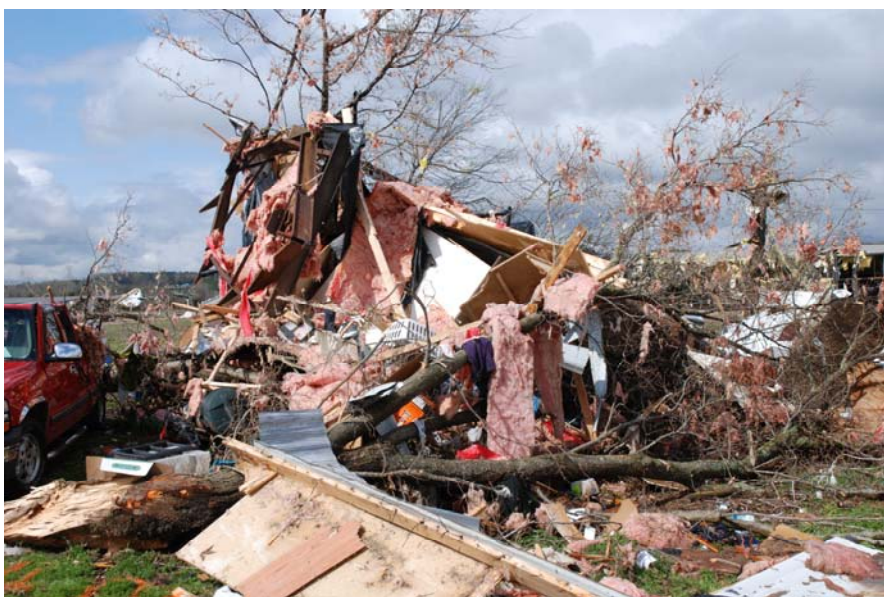
LINWOOD TORNADO - MOBILE HOME OFF OF CLARK ROAD

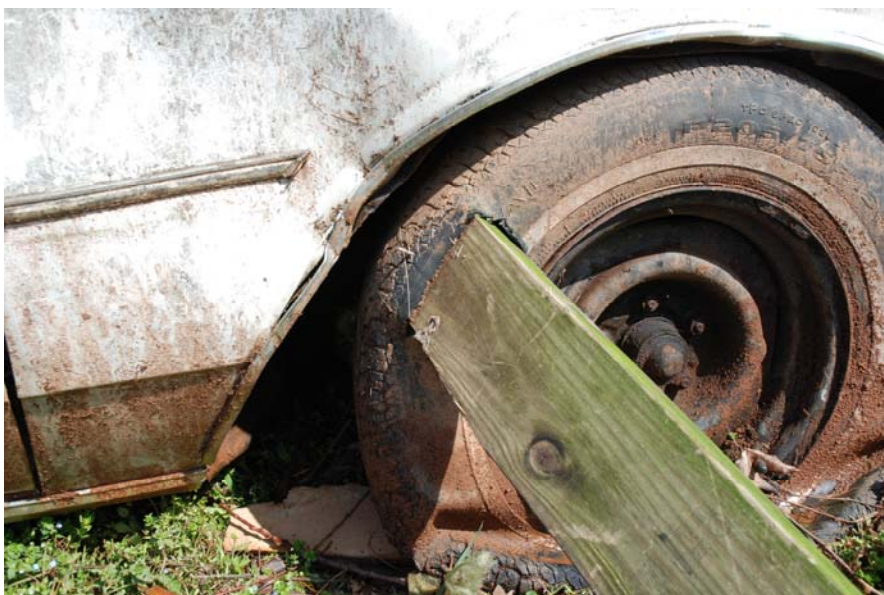
CLARK ROAD TORNADO - 2X4 THROUGH A TIRE

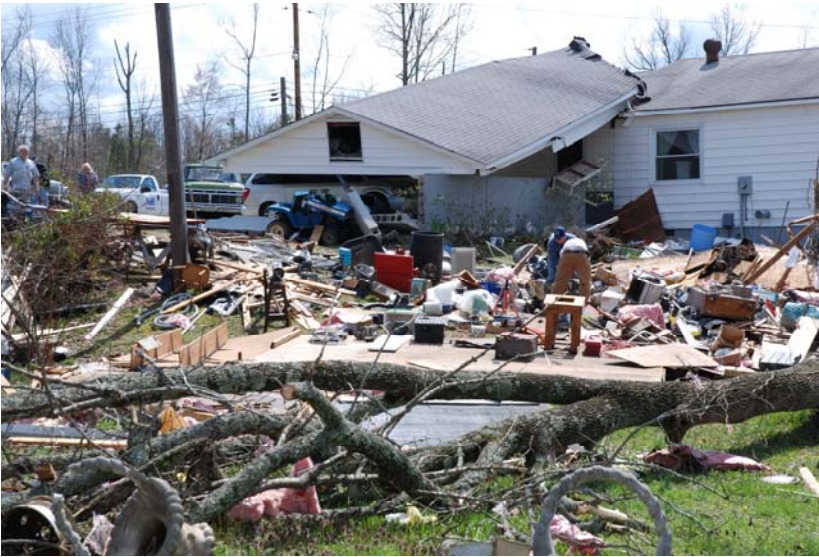
At approximately 715 pm EDT a second tornado touched down in a wooded area causing extensive tree damage south of Carpenter Road extension. The tornado tracked northeast across Carpenter Road extension where it caused minor damage to a single family residence when it destroyed the attached carport. The tornado then tracked a half of a mile over a wooded area where it then hit the southeastern corner of the valley mobile home park located off Sink Lake Road. One mobile home was completely destroyed when it was blown from the anchor points and displaced into an adjacent lake. Four occupants were inside the home and had to swim to shore. Along with the mobile home...the residents full sized SUV was also lifted and deposited into the lake. An additional five to six mobile homes sustained significant damage from fallen trees and flying debris as well as being shifted from their anchor supports. Remarkably...there were no serious injuries. The tornado quickly lifted in a wooded area about 100 yards north of the mobile home park. The total length of the tornado path was approximately 0.7 miles long and 25-50 yards in width. Damage was consistent with wind speeds of 80-100 mph...rating this an EF-1 tornado on the Enhanced Fujita Scale.

SINK LAKE TORNADO - CARPORT DESTROYED ATTACHED TO HOUSE ON CARPENTER ROAD EXTENSION

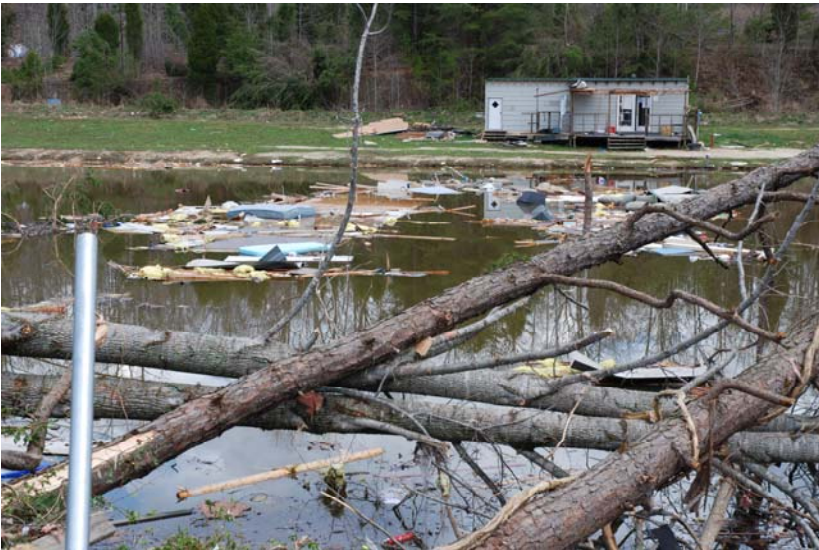
SINK LAKE TORNADO - MOBILE HOME DAMAGE IN SINK LAKE

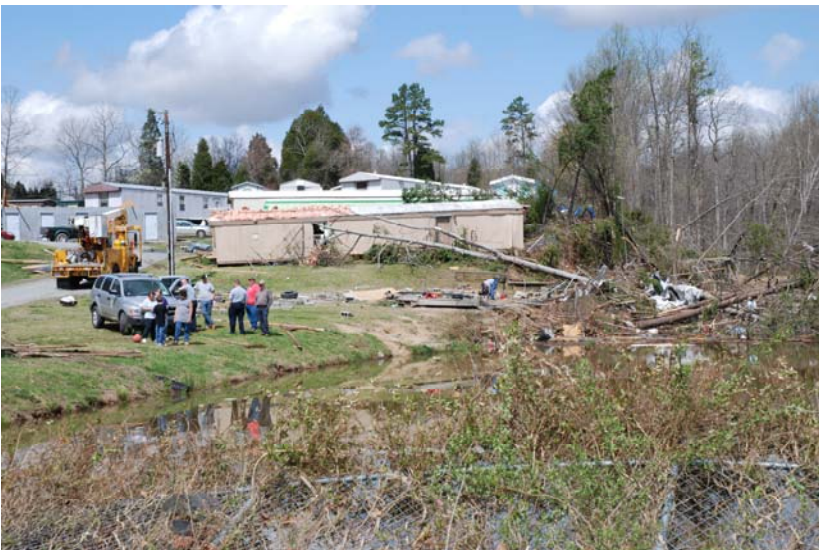
SINK LAKE TORNADO - MOBILE HOME DAMAGE
